BASEWIDE POLYCHLORINATED BIPHENYL CONFIRMATION SAMPLING SUMMARY REPORT

MARE ISLAND, CALIFORNIA

VOLUME II
CONFIRMATION SAMPLING
SUMMARIES BY PARCEL

PARCEL 01-C

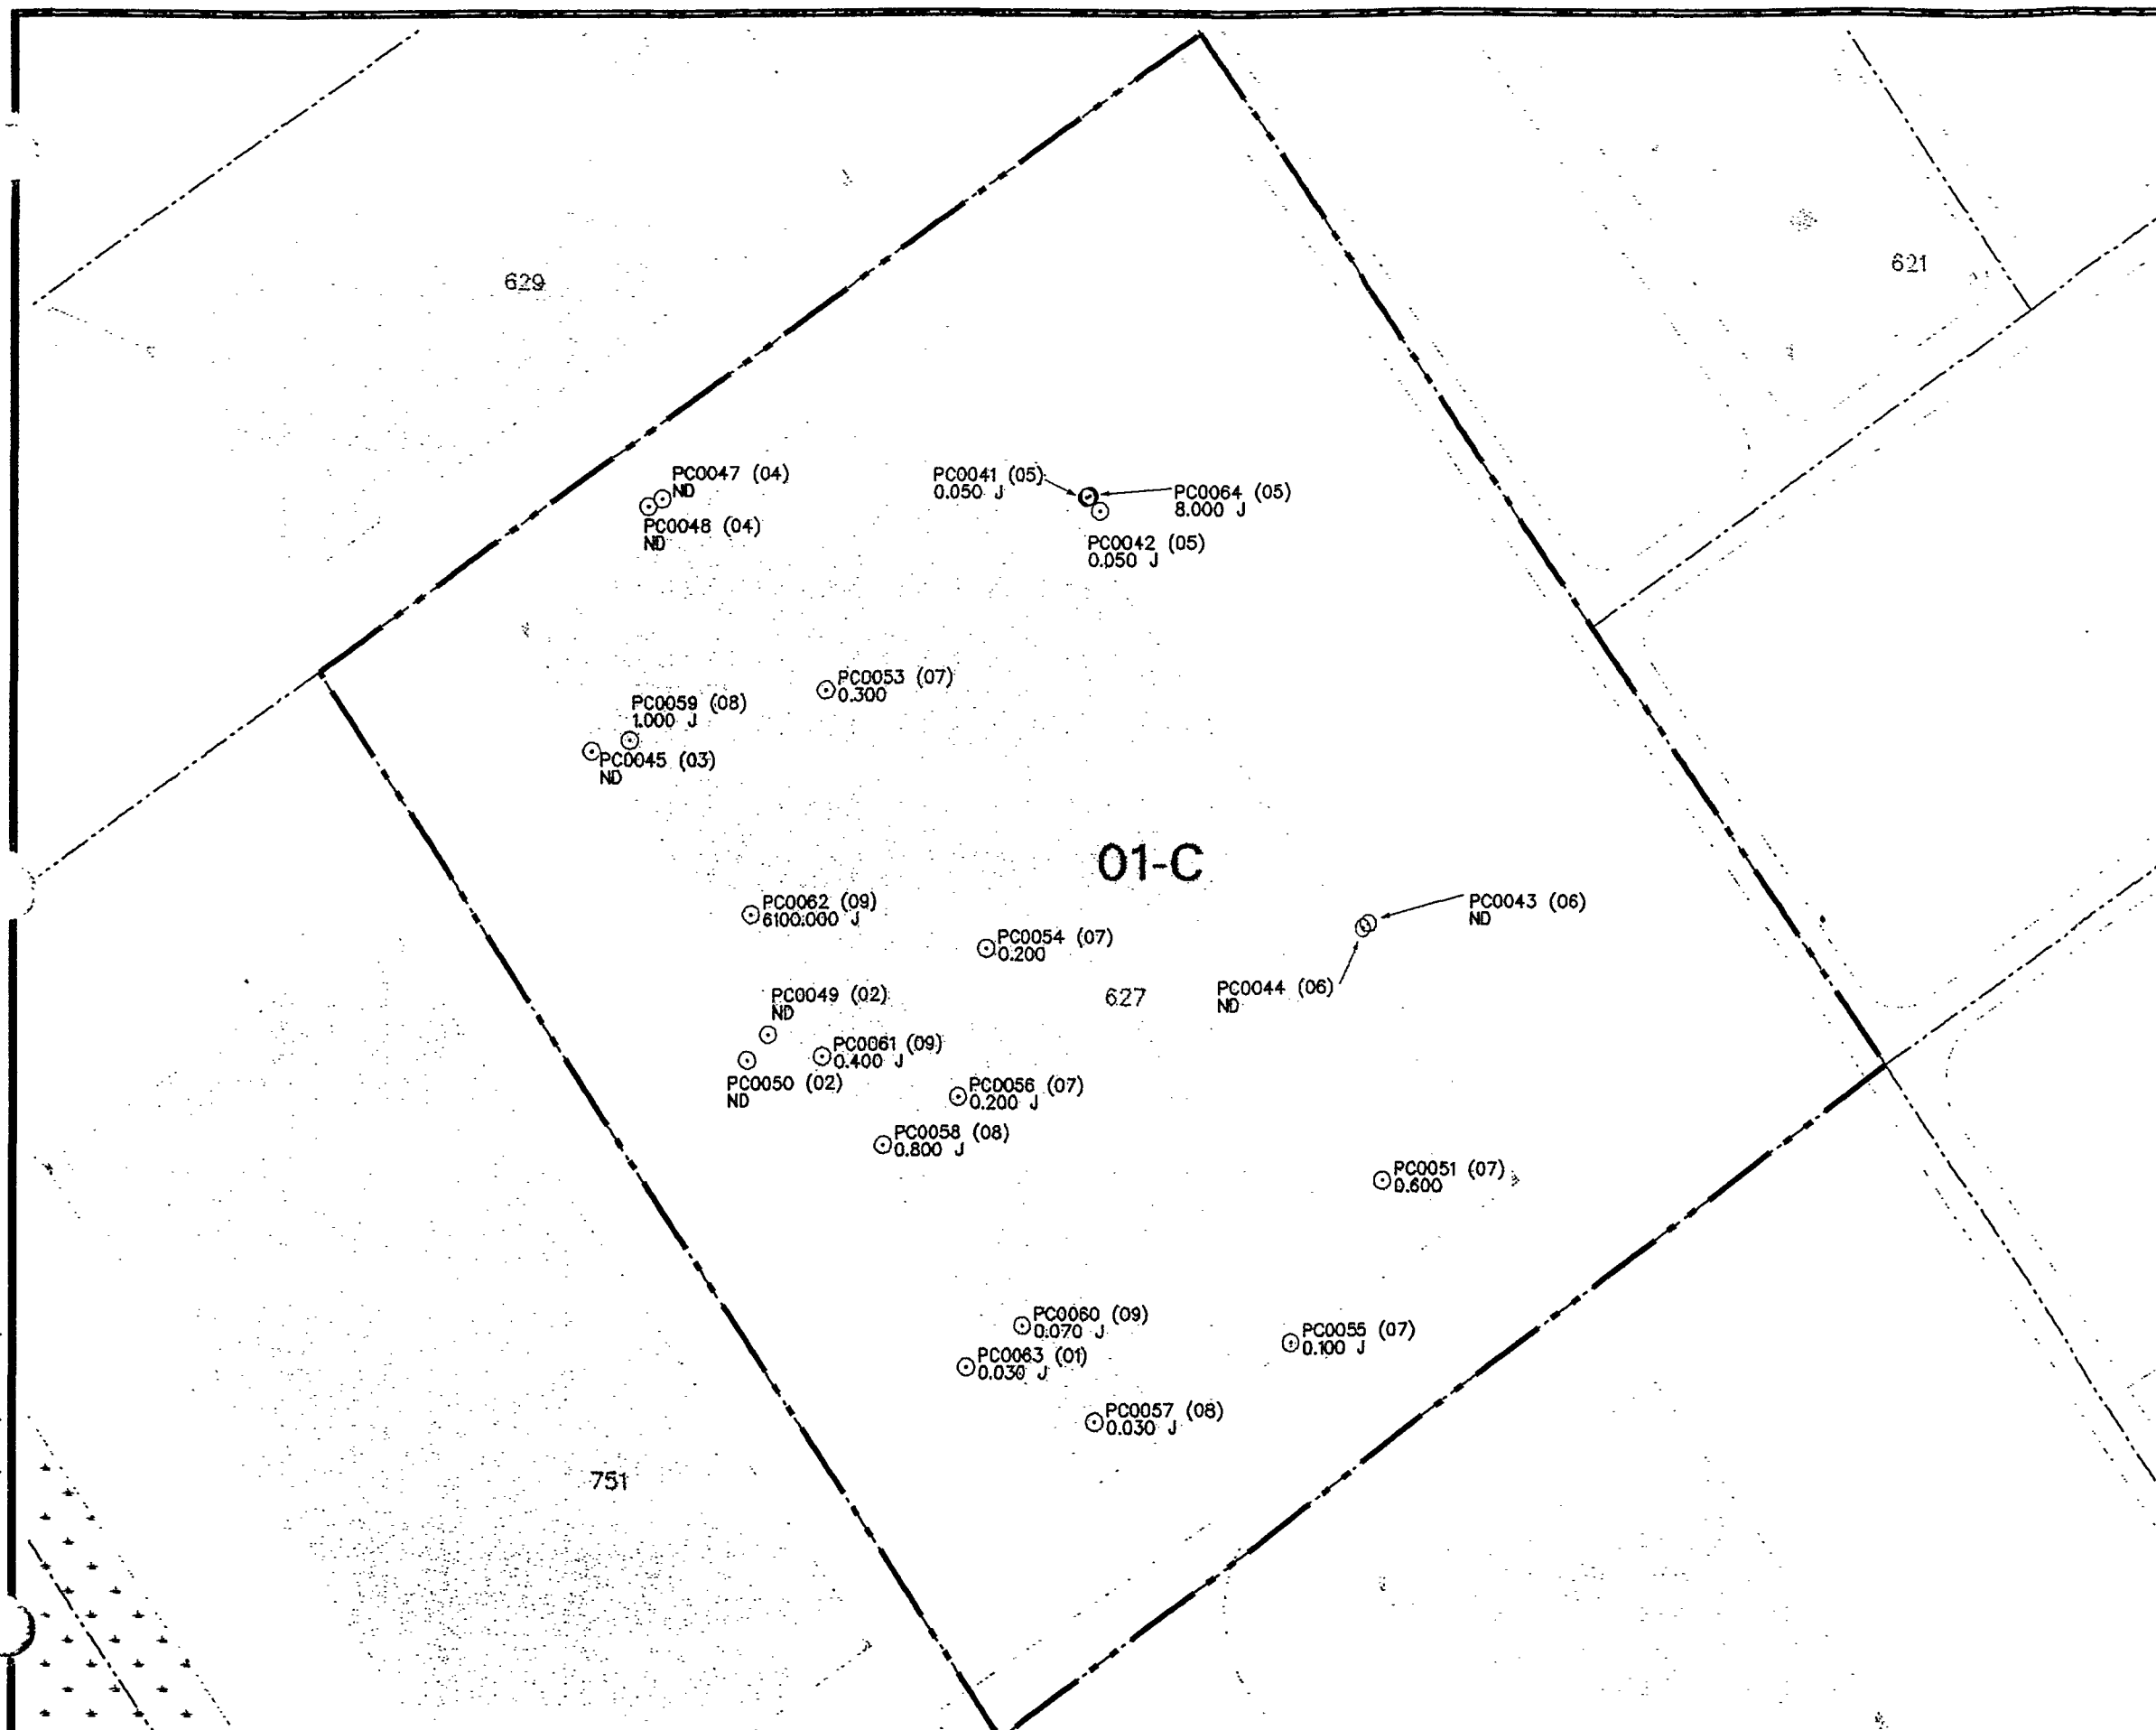
PHASE I
PCB CONFIRMATION SAMPLE
LOCATIONS AND RESULTS

Analytical results for the confirmation sampling inside and outside Building 627 are summarized on the Parcel 01-C table for Building 627 provided after this text. In samples from Assessment Locations 02, 03, 04, and 06, PCBs were not detectable. The concentration in the sample from Assessment Location 01 was below 0.067 mg/kg. The highest PCB concentration, estimated at 6,100 mg/kg, was detected in a wood sample from Assessment Location 09, on the third floor mezzanine; other samples from this location had estimated concentrations of 0.07 and 0.4 mg/kg. Estimated PCB concentrations in samples from the first floor and second floor mezzanine, Assessment Locations 07 and 08, ranged from below 0.067 to 1.0 mg/kg. Outside Building 627, samples from Assessment Location 05 had estimated PCB concentrations below 0.067 in concrete and at 8.0 mg/kg in soil.

| Inside/ Outside | PCB Assessment Location | Location Description | Sample Identification Number | Sample Matrix | PCB Concentration (mg/kg) |
|---|---|---|---|---|---|
| | | Third floor¹ | PC0062 | Wood | 6,100 J |

One location in Parcel 01-C requires additional abatement and confirmation sampling:

- PCB Assessment Location 09 - third floor

After additional abatement has been completed at this location and subsequent confirmation samples show that PCB concentrations are below the 10 mg/kg screening criteria, an addendum to this report including the additional confirmation sampling results and BCT notification form, will be submitted for insertion.
